Inspection Report

This home inspection report prepared specifically for:

**Robert Needsahome
200 Foundone Lane
Pittsburgh, PA 15101**

200 Foundone Lane

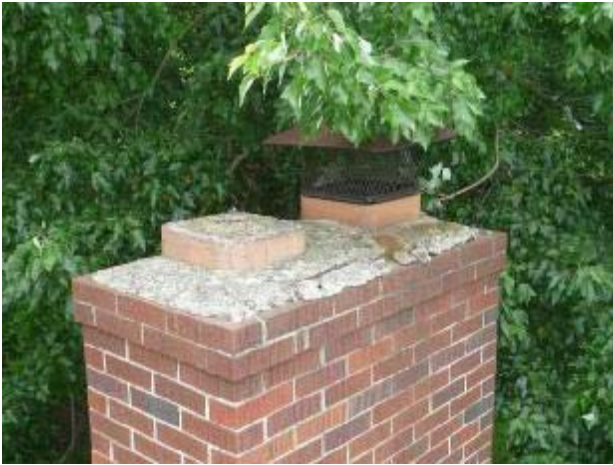
Roof # R1

Cracks and separations were noted at the masonry chimney shroud. Openings at this upper most portion of the chimney structure will allow water entry to the brick and mortar components. The appearance of white staining, known as efflorescence, may occur and is an indication of moisture entry into the chimney. More commonly the result is deteriorated mortar and loose or damaged brick at the upper portions of the chimney. Repair or replacement of the mortar shroud with appropriate materials will help to prevent damage to the chimney.

Deterioration at the mortar chimney cap

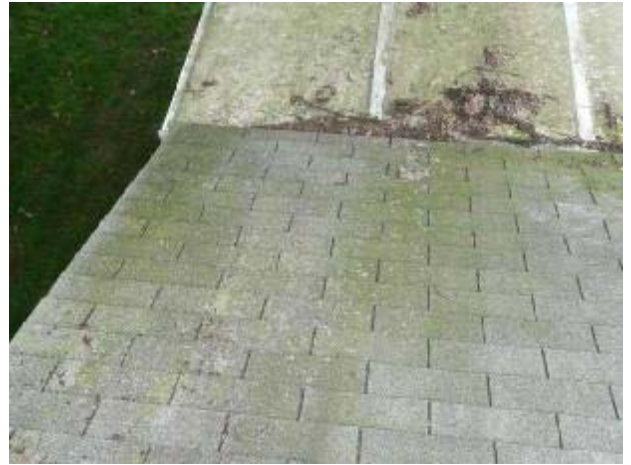
Roof # R2

Algae growth on shingles can shorten the life of the roofing materials it is growing on. Application of an algaecide will help to reduce the effect of the algae growth. Trimming overhanging branches will help to provide sunlight that will also reduce algae growth.

Algae and debris at the roof

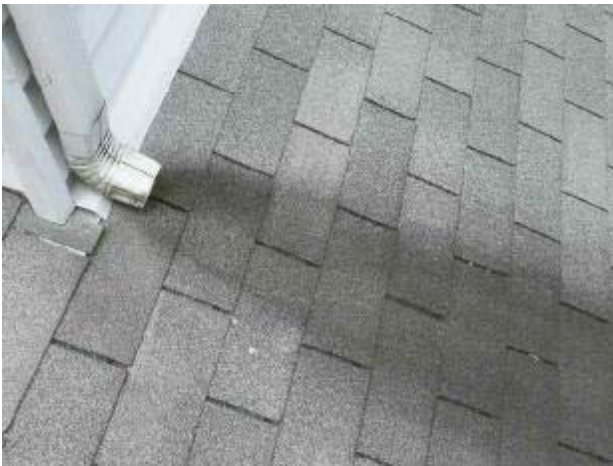
Roof # R3

Gutters & downspouts that discharge onto roof surfaces may result in ice build-up or deterioration that can lead to leakage. Alteration should be considered where practical.

Downspouts discharge onto lower roof surfaces.

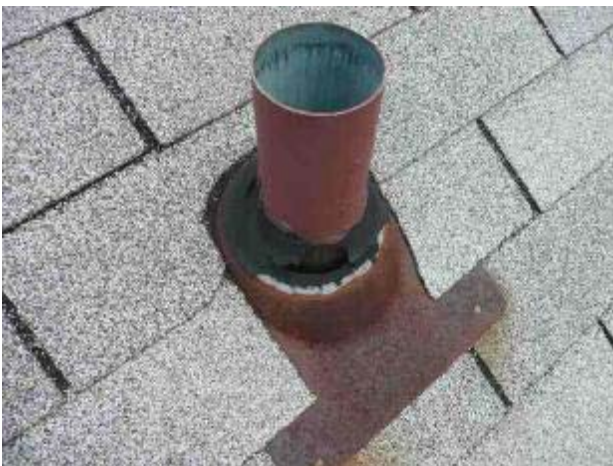
Roof # R5

Separations in the flashing materials will allow water to enter the roof and attic structures. Evaluation by a qualified roofing contractor for repair and proper flashing installation technique is recommended to help prevent further water entry. Noted at the plumbing vents.

Exposed nail heads at the flashings are prone to leakage even if covered with mastic. This is not a recommended installation practice. Regular inspection including application of additional mastic will help to reduce the possibility of leakage.

Separations at plumbing flashings and exposed nail heads.

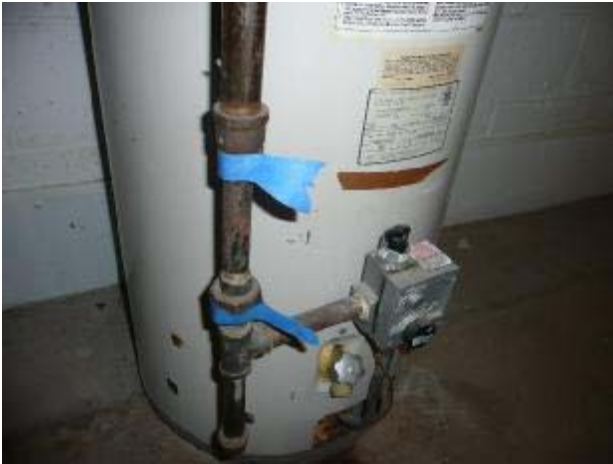
HC3

Readily accessible natural gas fittings were tested for leakage using an electronic combustible gas detector. Discovered leaks are marked with ribbon. Not all portions of the gas supply lines are visible or accessible. Further evaluation and repair by a qualified contractor are recommended.

Example of gas leaks

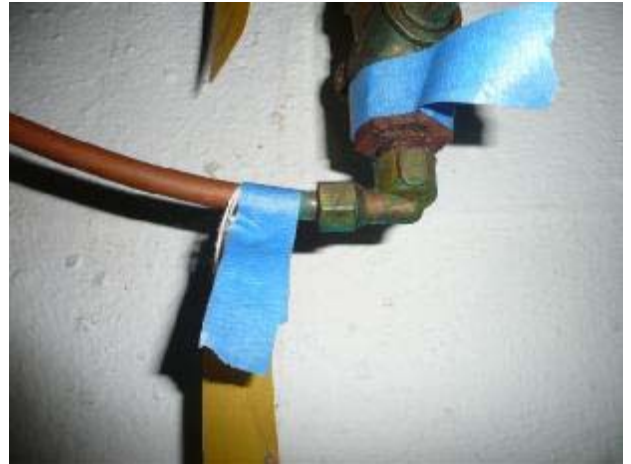
HC4

Water related fittings were noted to be installed at the gas lines. Water valves and / or compression fittings are not rated for gas usage and should be replaced with appropriate fittings or rated appliance connectors. Noted to be leaking at the dryer service.

Compression fittings at the dryer branch

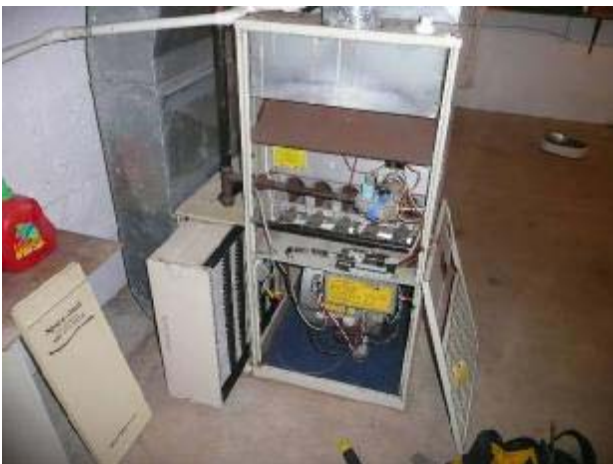
HC5

The automatic gas valve at the furnace is leaking fuel through to the burners. Evaluation is recommended.

The furnace did not respond in a timely manner to normal controls. This appears to be a thermocouple defect. These heat sensing devices commonly go bad for several reasons including age and are replaceable. Over five minutes elapsed before the burners responded.

What appears to be a crack was noted at the right rear upper portion of the right chamber. Further evaluation is recommended due to the lack of visual access being blocked by the automatic gas controls.

Furnace

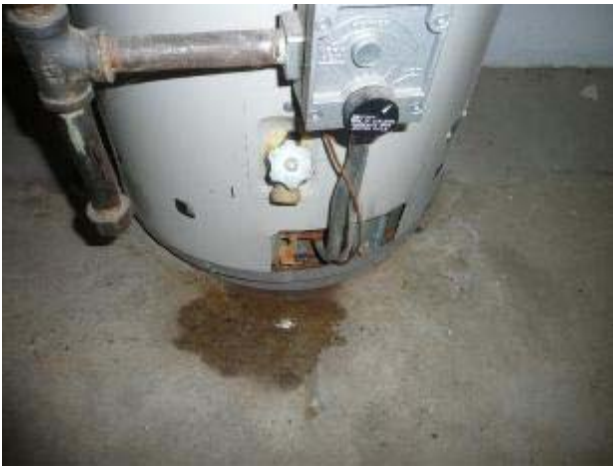
Plumbing # P3

Leaking drain valve, missing flame guard

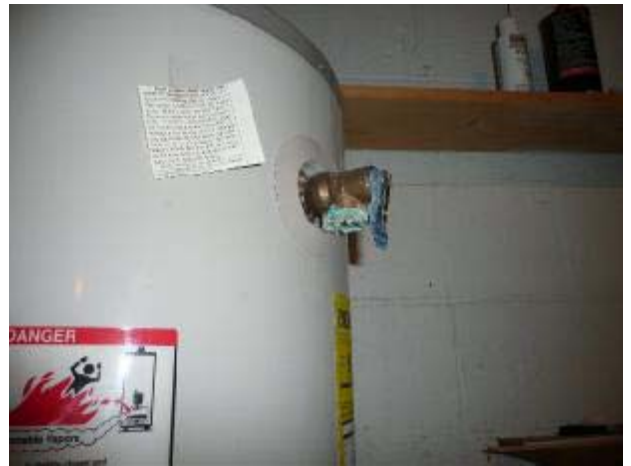
Plumbing # P4

Evidence of leakage at TPR valve, missing TPR pipe

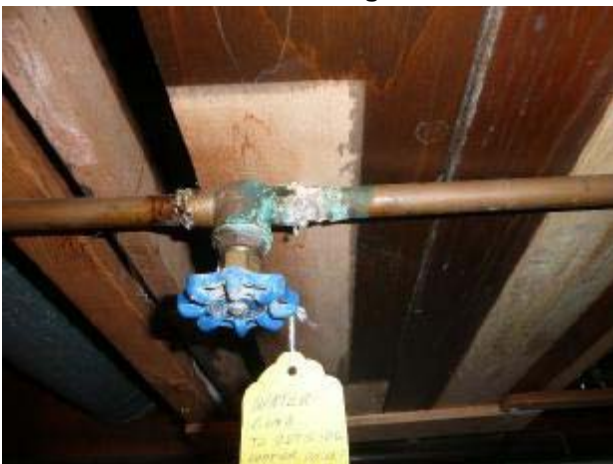
Plumbing # P5

Example of corrosion at supply lines

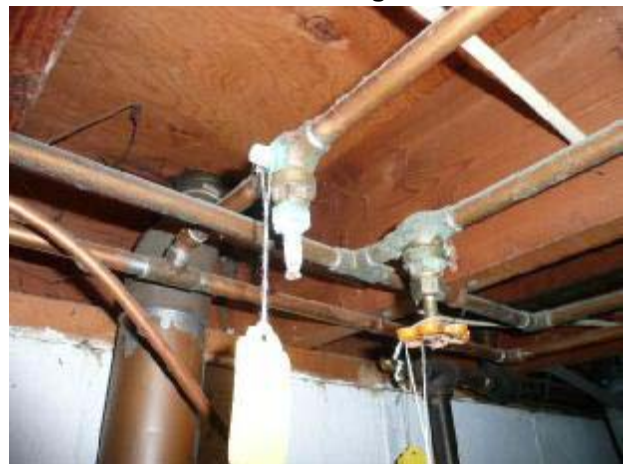
Plumbing # P6

Example of corrosion at supply lines

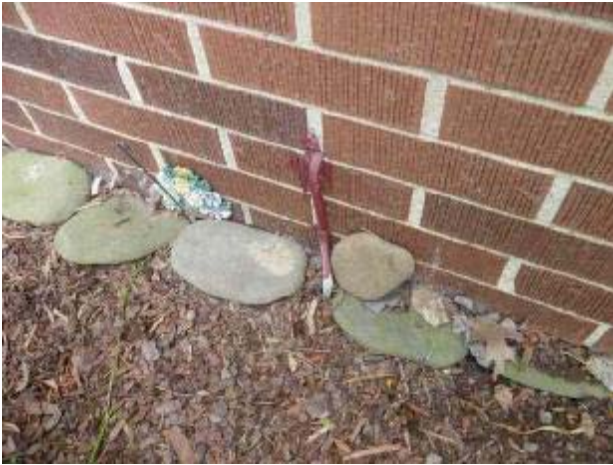
Electrical # EL1

Un protected wiring was noted at ground level leading to the lamp post.

Exposed electrical wire at ground level

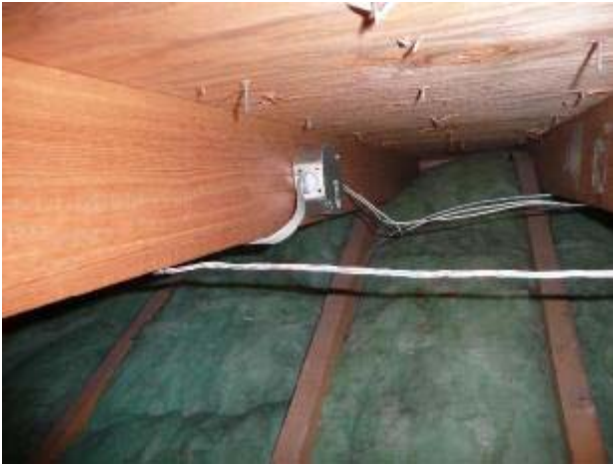
Electrical # EL3

Improper wiring was noted in the garage attic area.

Improper wiring found at the garage attic.

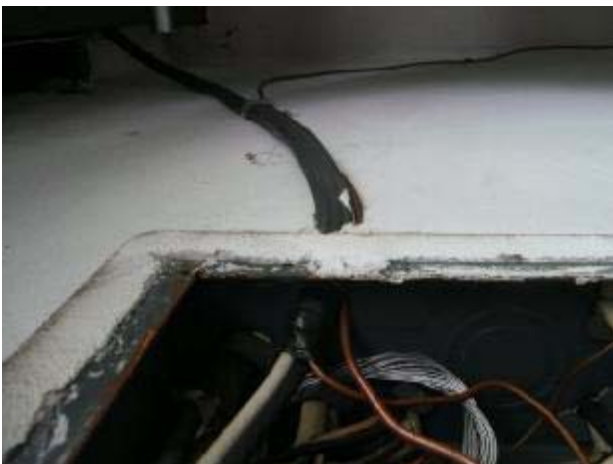
Electrical # EL5

A wire is exiting the main panel through an un protected opening in the top of the box and through the wall. A proper wire connector is recommended.

Improperly routed electrical wire.

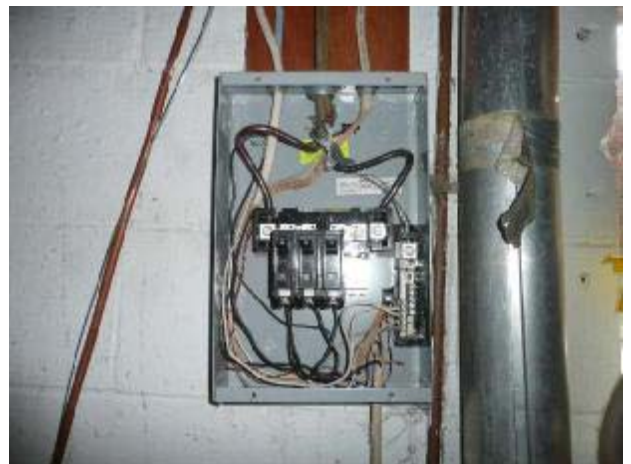
Electrical # EL6

Double tapping was found at one or more of the terminals. Only one wire may be located under a terminal screw unless it is specifically designated for such use. Replacement with an approved breaker(s) or is recommended. Noted in the sub panel.

Neutral and ground wires are connected at the sub panel. Each of these conductors should be kept seperate to provide designated return paths to the main panel. Repairs or alteration by a qualified electrician are recommended. Noted at the sub panel.

Basement sub panel.

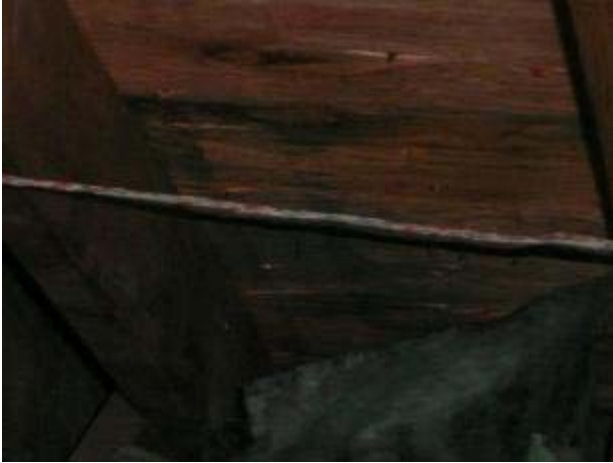
Attic # A1

What potentially appears to be mold was noted in the attic area on the sheathing. Possible causes for this condition include attic ventilation deficiencies, bathroom ventilation deficiencies, roof leakage and the maintaining of excessively high humidity levels in the living area. Testing of the discolored area for the presence of mold is recommended by a qualified contractor.

Smaller area of mold found at left rear corner of the garage attic

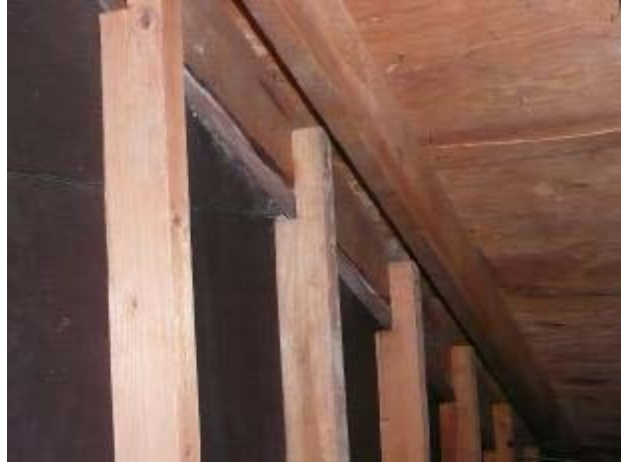
Attic # A2

Smaller areas of staining at the chimney area.

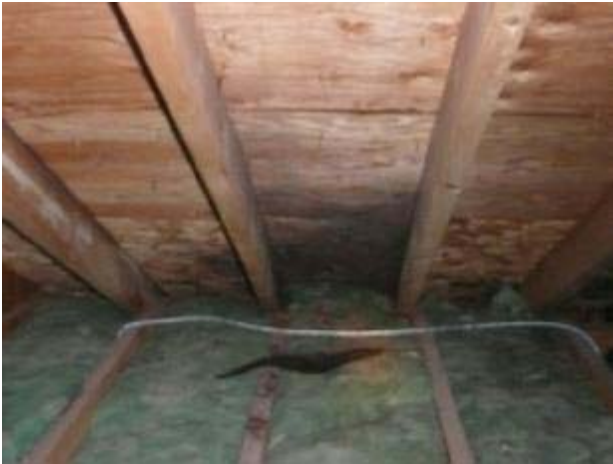
Attic # A3

Mold above the bathroom

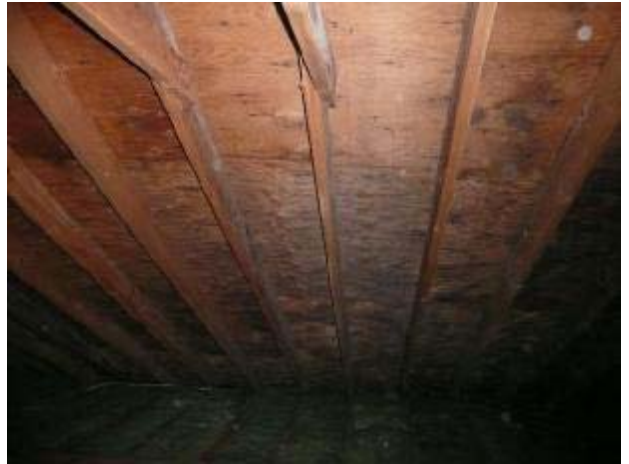
Attic # A4

Mold at the front field

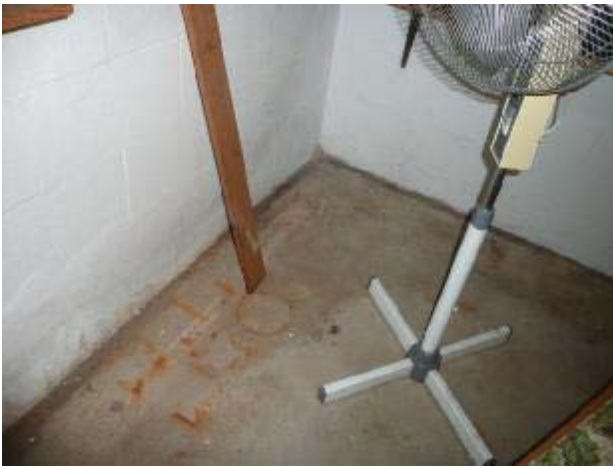
Foundation # F3

Evidence of moisture entry into the foundation area was visible. The most common causes for moisture entry to the foundation area include soil or walking surfaces sloping toward the foundation, malfunctioning roof drainage systems, over grown vegetation and improperly directed sprinkler systems. Any and all applicable exterior contributing conditions should be addressed to keep as much water away from the foundation as possible. Moisture entry is a reoccurring condition that is weather and seasonally related. We cannot guarantee inactivity of any visible staining. Inquiry with the seller to document the frequency and degree of moisture or water entry is recommended. Minor staining at the right side of the basement.

Evidence of moisture entry at the right side

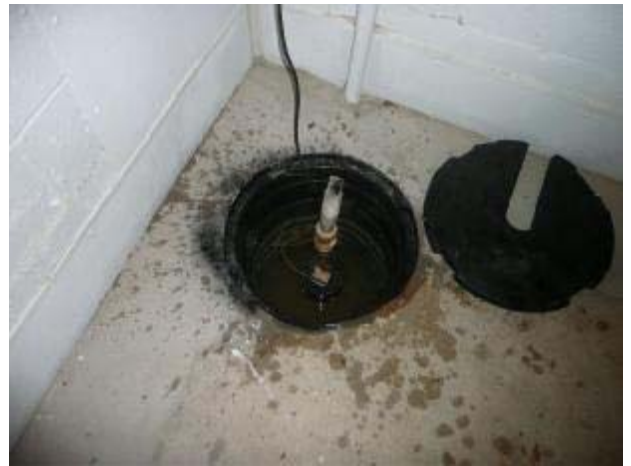
Foundation # F4

The presence of an interior water removal system and sump pump was noted. Inquiry with the seller about the reason for the installation and extent of the system is recommended. Most basement "waterproofing" companies offer transferrable warranties, looking into this is recommended. Installed at the right rear area of the basement.

Water removal system

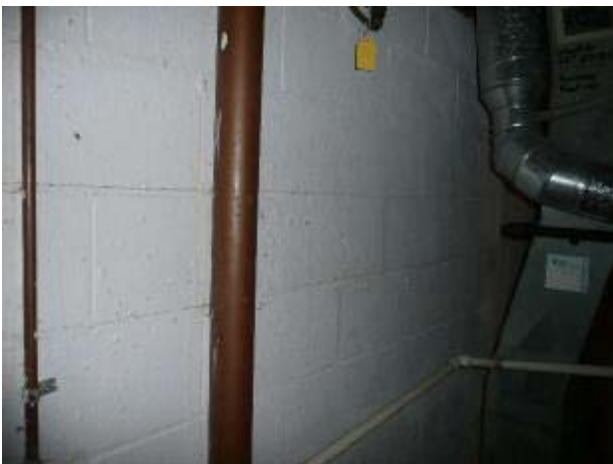
Foundation # F5

18 Horizontal cracking within three feet of the exterior grade was visible. Evidence of movement such as this in our climate zone is commonly referred to as frost heaving. Although not only a result of freezing soil, other factors that may contribute to this condition include saturated soil, expansive soil and improper soil slope toward the foundation. These cracks will typically get slightly larger during the winter and wet seasons due to lateral pressure. During the summer and dry seasons the cracks will diminish due to the shrinkage of the drying soil and the vertical load of the building structure. Concerning this seasonal movement of the wall it is important not to fill the created opening with a solid material, like mortar, as this will create a "wedge" that does not allow to move back towards plumb during the dry seasons. Although this type of cracking is common and currently does not appear to have created a significant problem, monitoring for any unusual movement is recommended so that timely and minimally invasive correction can be performed. Any and all exterior contributing factors concerning landscaping and roof drainage conditions should be addressed in order to keep water away from this particular section of the foundation.

Horizontal cracking at the rear wall.
